Rail Accident Investigation Branch

Rail Accident Report

Extensive track damage between Ferryside and Llangennech, Carmarthenshire 30 October 2017

Report 17/2018
October 2018

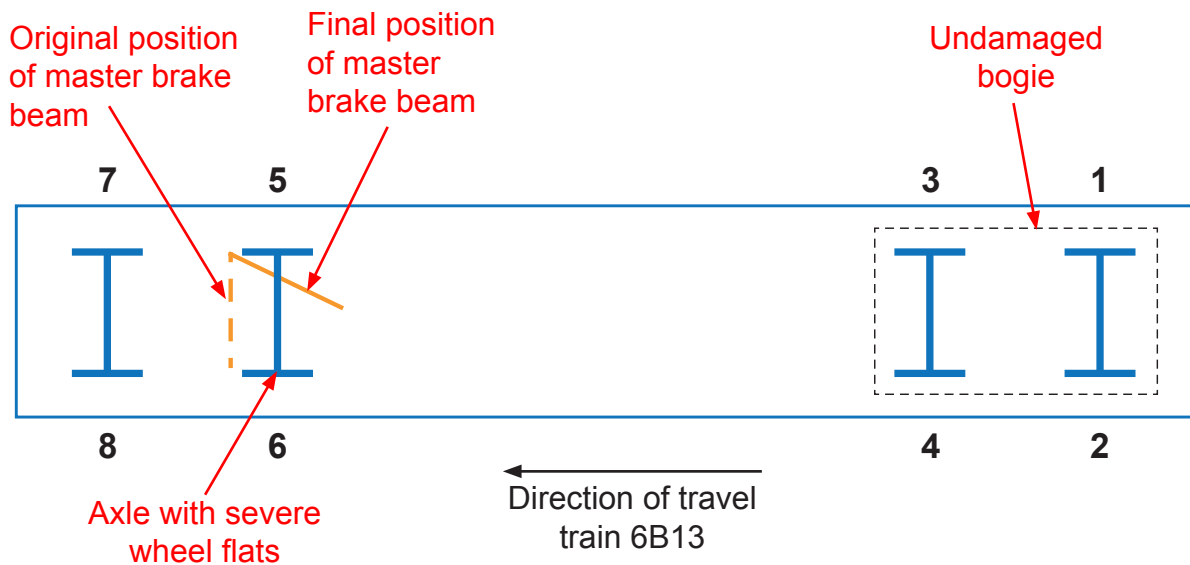
Figure D1: Schematic of wagon GERS89009 showing wheel numbering and the final position of the master brake beam

- D1 After train 6B13 was moved to Margam (paragraph 46), wagon GERS89009 was detached and held for examination. The diesel fuel was drained from the wagon on 8 January 2018, allowing the wagon to be lifted and the damaged leading bogie, no. 2741, to be swapped on 25 January. The bogie was then taken to Axiom Rail (Wabtec Faiveley) at Stoke on Trent, where it was examined by representatives of Touax Rail, DB Cargo, Wabtec Faiveley, Serco, ORR and RAIB on 13 February.
- D2 Examination of the bogie revealed that the lower left-hand hanger pin had sheared on the master brake beam, allowing the end of the brake beam to break free. The right-hand hanger was still intact, although twisted, and had pulled the partially detached beam along the four foot (figure D1).

- D3 The master brake beam had bent around the middle (figure D2). The bending was consistent with the beam having come into contact with the trailing axle of the bogie while bouncing along at speed under the wagon. The left-hand block holder (wheel position 6) was missing from the end of the beam; part of it (the outer face) was later found 62.1 miles (100.0 km) from Robeston.
